## North Coast Regional Water Quality Control Board

### **Inspection Report for September 3, 2019 Warrant Inspection Humboldt County Assessor's Parcel Number 212-071-001**

File: Cannabis Program Inspections, Humboldt County, September 2019 HCSO  
CAMP Inspections, Kenneth W. Willis, CIWQS Place ID 861047

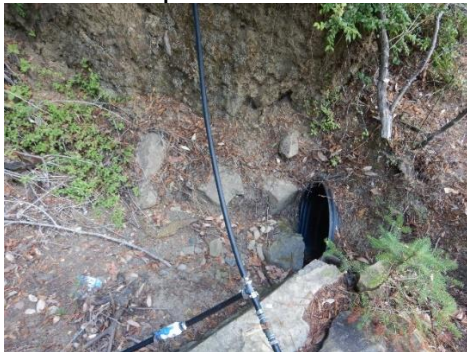
Figure 2. Ditch to culvert inlet on Class III watercourse. Photo by Ermias Berhe.

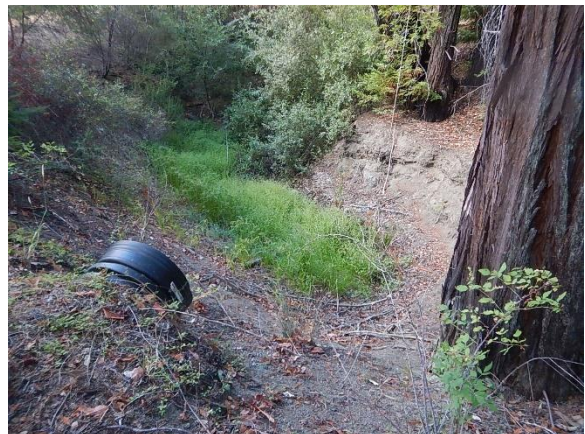
Figure 3. Culvert outlet to the excavated Pond at Map Point 17.

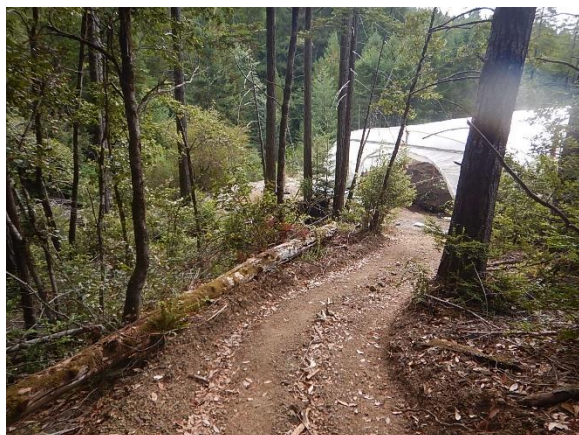
Figure 4. Access road between Pond and CA3.

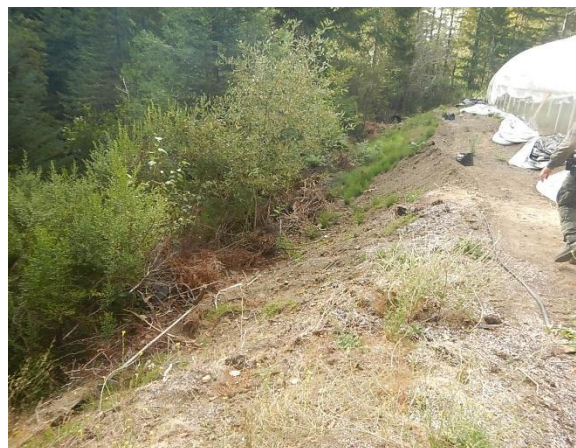
Figure 7. Outboard fill at CA3.

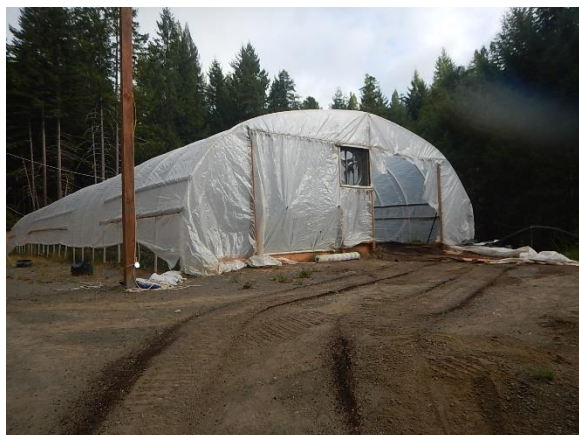
Figure 5. CA3 greenhouse. Thick dust covers the road and flat surface.

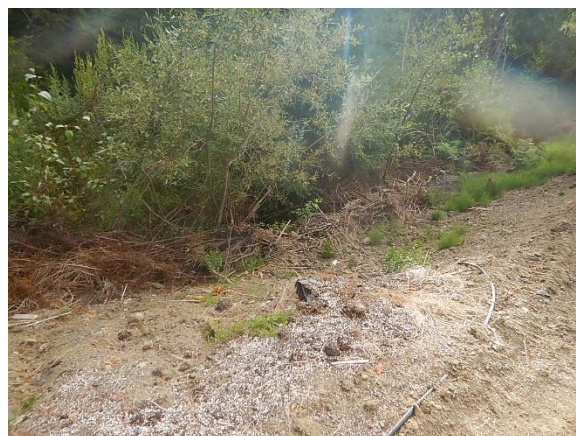
Figure 8. Cultivation waste tossed over the fill face at CA3.

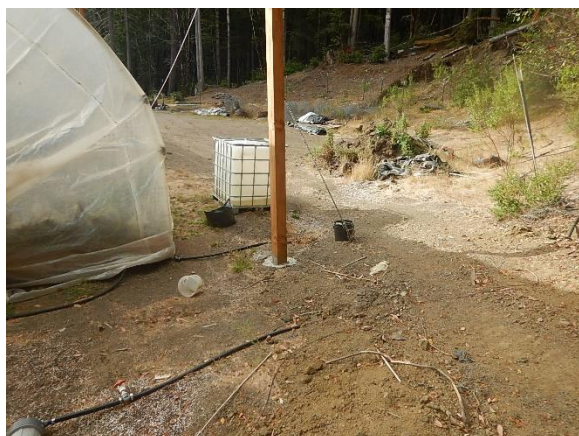
6. Irrigation runoff: At CA3, I observed one location where irrigation water may have drained from the greenhouse onto the ground outside (see Photo 6). Cultivation areas CA1 and CA3 are hydrologically connected to the stream network.

Figure 6. Wet ground at CA3 due to irrigation.

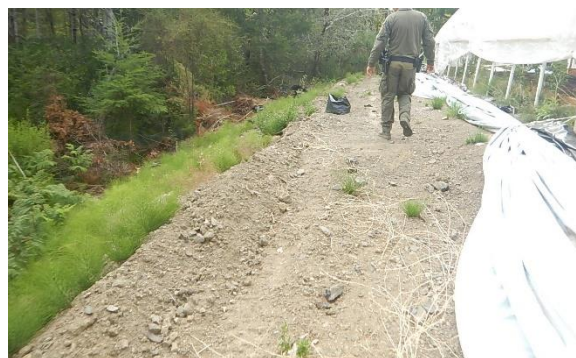
Figure 9. Loose fill perched at the outboard edge of the fill at CA3.

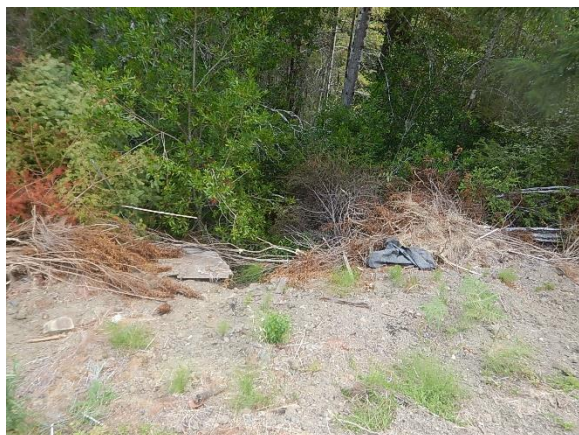
Figure 10. Slash and debris placed over the edge of the fill slope at CA3.

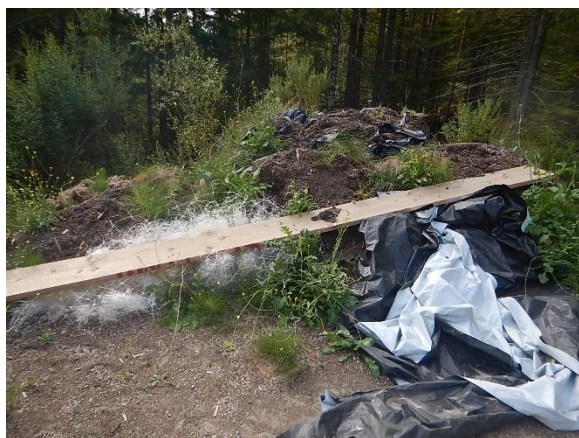
Figure 11. Earthen spoils placed on the outboard edge of the fill at CA3 (Map Point 21).

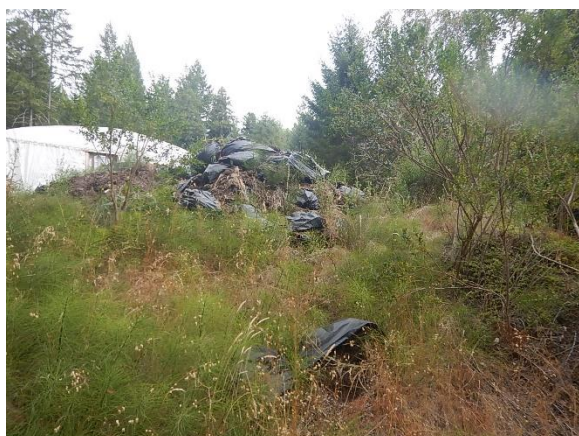
Figure 12. Fill slope at CA3, Map Point 21 with loose fill and soil-filled grow bags, positioned to transport down the road to the Class II watercourse.

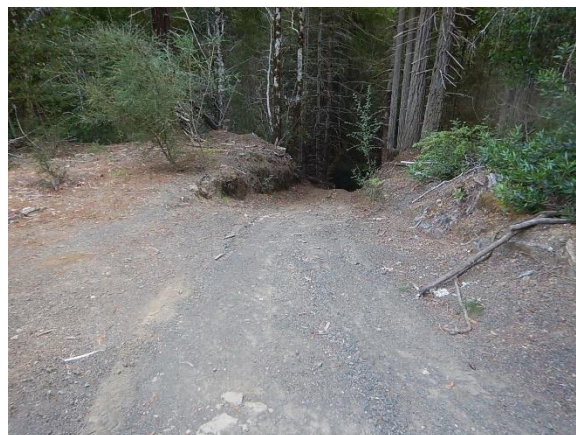
Figure 14. Below flat road dives steeply via a through cut toward Class II watercourse crossing.

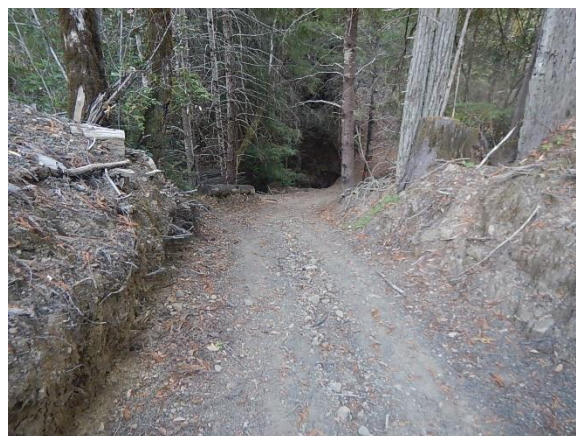
Figure 15. Through cut road approach to Class II crossing (Map Point 19)

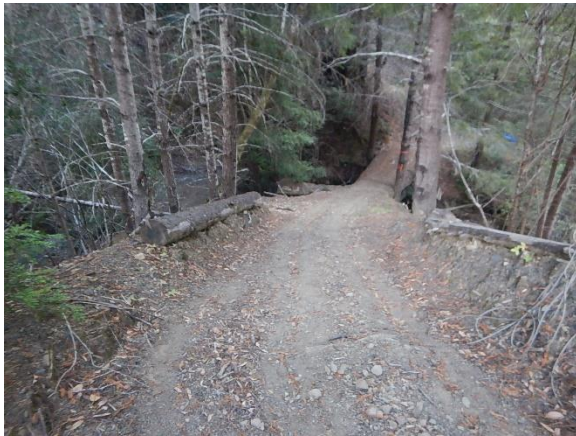
The road continues downhill and northward, to a cannabis cultivation area, CA3 (Map Point 21), then heads southeast, and dives down very steeply to a Class II watercourse, where there is a stringer bridge (Map Point 20). and then continues steeply up the eastern slope above the watercourse. The western road approach concentrates water via a through-cut, and the road surface is rilled due to concentrated runoff. I observed earthen fill pushed off the side of the road where it could deliver into the watercourse. The eastern side road approach is also steep, rilled, and I observed earthen material pushed off the side of the road perched where it could deliver to the watercourse. The siting and construction of both road approaches have caused and resulted in sediment placement and delivery into and where it can enter the Class II watercourse. I observed debris racks/jams both up- and downstream of the bridge. The bridge appears to have the potential to impede the flow of debris. (Map Point 19).

Figure 16. Looking at the Class II stringer crossing (Map Point 20) from western bank road approach; downstream is to the right of the photo.

- a. Remove the fill associated with the Bridge at Map Point 20 and restore the Class II watercourse and associated riparian area to its natural state.
  - b. Remove the fill associated with onstream pond at Map Points 17 and 18 and restore the Class III watercourse channel to its natural state.
  - c. Dispose of all development and restoration-related earthen spoils in a manner to prevent/minimize transport and delivery to receiving waters.
3. Prior to conducting any instream work associated with recommendations 1 and 2, above, submit to the Regional Water Board an application for Clean Water Act section 401 water quality certification, and secure approval from the Regional Water Board.

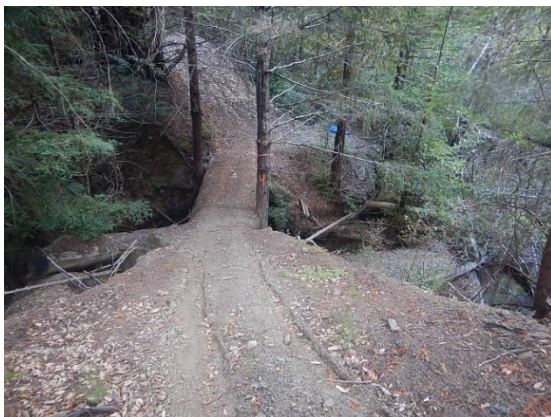
Figure 17. Looking at Class II Crossing (Map Point 20) from western bank road approach; downstream is to the right of photo. Note Crossing is constructed of logs and native earth. The crossing acts as a constriction. Sediment and debris accumulation is evident in channel, both upstream and downstream.

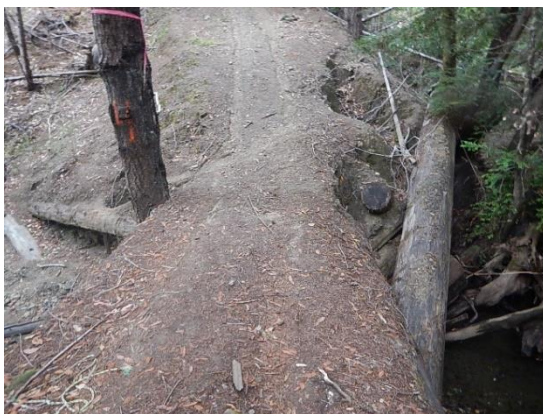
Figure 18. View from crossing surface looking at western bank; downstream is on left of photo. Note erosional voids in earthen material, exposing logs of crossing.

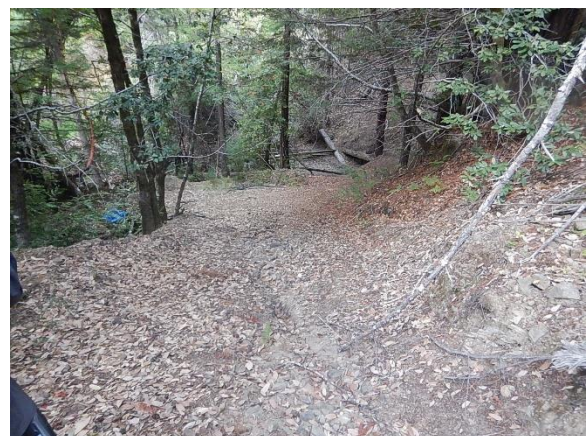
Figure 21. Looking down at crossing from eastern bank road approach which is very steep and entirely hydrologically connected to the crossing.

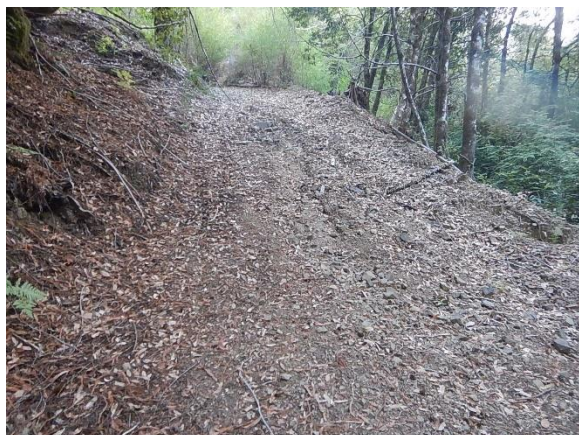
Figure 22. Eastern bank road surface is rilled.

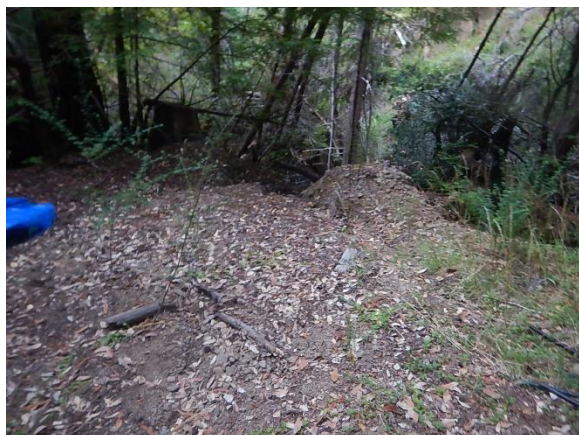
Figure 23. Perched fill on LB road segment above crossing.

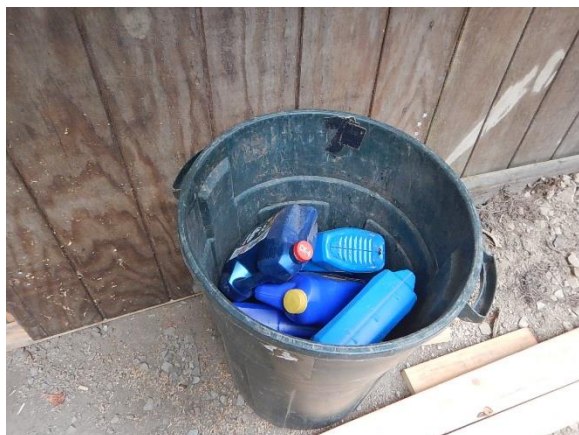
Figure 28. Waste oil containers are contained.

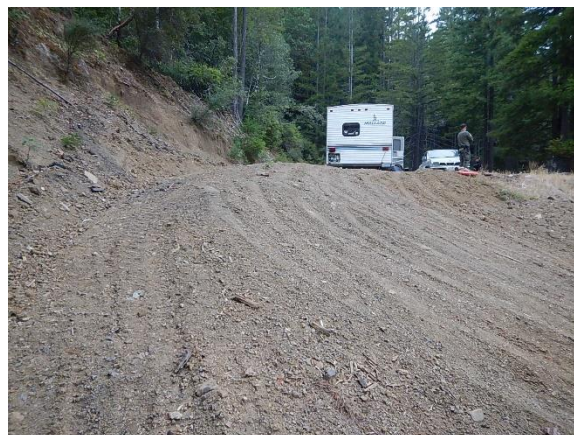
5	RV Septic Construction	Recent grading associated with septic located near steep slope. Earthwork has caused or created features with high potential for erosion and transport to and into a watercourse at Map Point 8.	Construction-related waste placed where it can enter a watercourse	Figures 30-33

Figure 31. Recent grading on steep slope below septic.

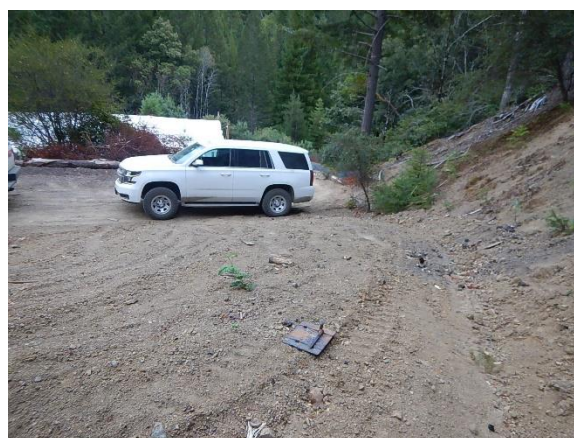
Figure 32. Recent graded slope concentrates stormwater down steep road toward CA1.

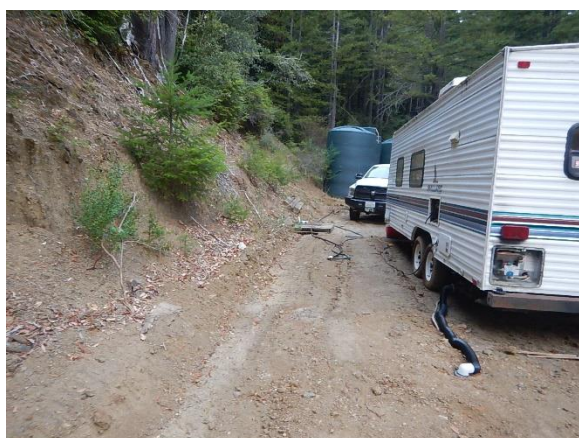
Figure 30. RV connected to onsite waste system, presumably a septic system (Map Point 5).

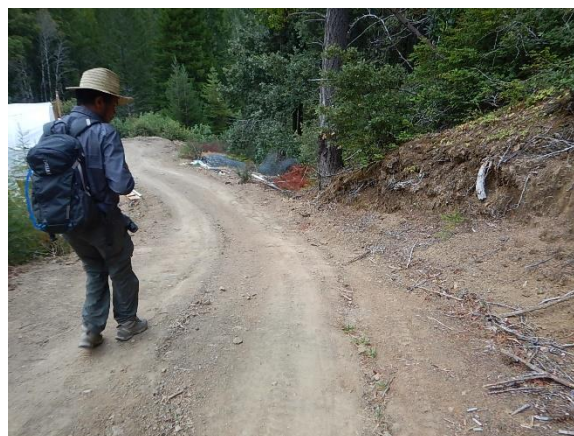
Figure 33. Road surface is rilled between septic and CA1.

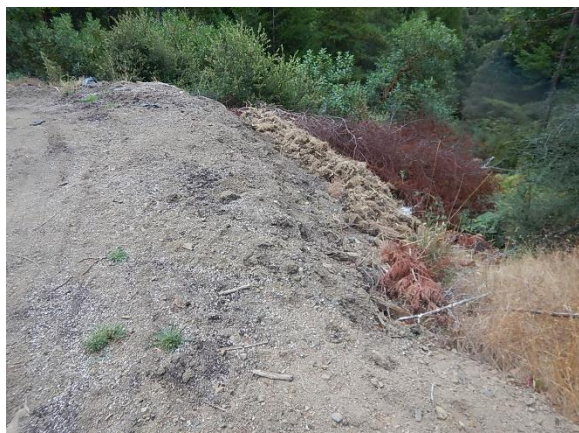
Along the south edge of CA1, at Map Point 6, I observed cultivation waste that had been pushed or placed over the edge of the roadway, including root balls, potting soil, and earthen spoils. These materials are in the drainage path discussed above, at a location where they are susceptible to contact with and transport by storm water runoff down the road and hillslope to the class III and class II watercourses (Map Points 8 and 9, respectively).

Figure 34. Cultivation waste including stalks and root balls and soil placed over outboard edge of roadway, unprotected from concentrated runoff (Map Point 6).

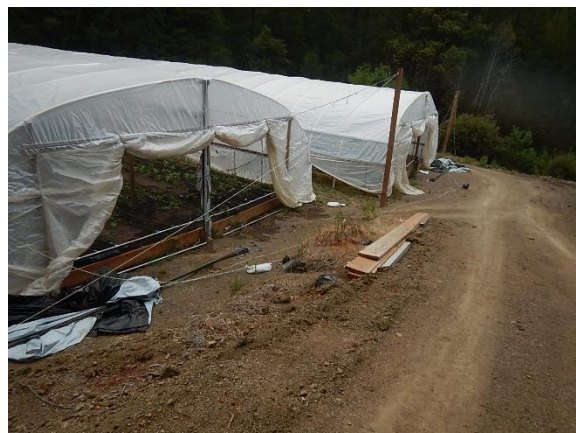
Figure 37. Runoff from CA1 joins runoff from the roadway and is transported down the roadway (Map Point 7).

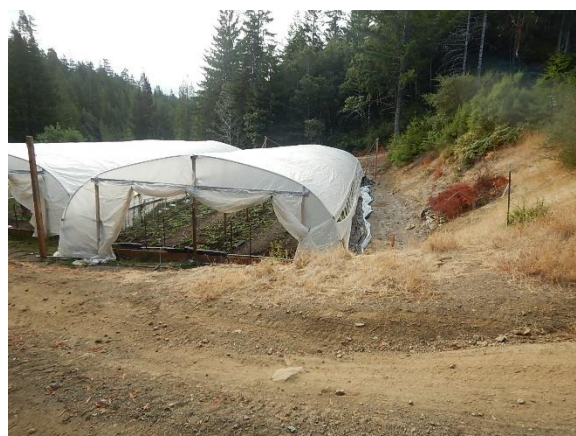
Figure 38. on either side of CA1 are roads that are rilled and concentrating stormwater runoff.

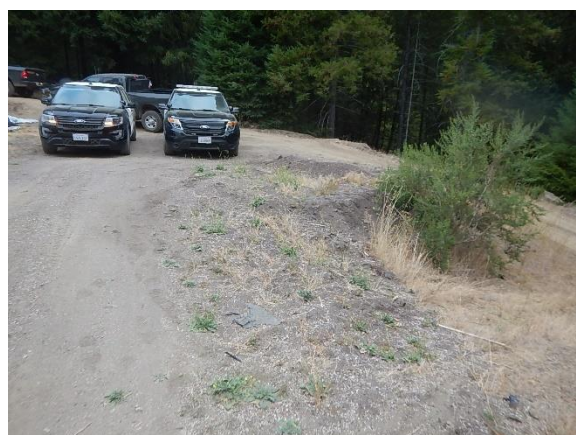
Figure 39. Road runs below CA1 and concentrates the two approach roads, the cultivation flat CA1.

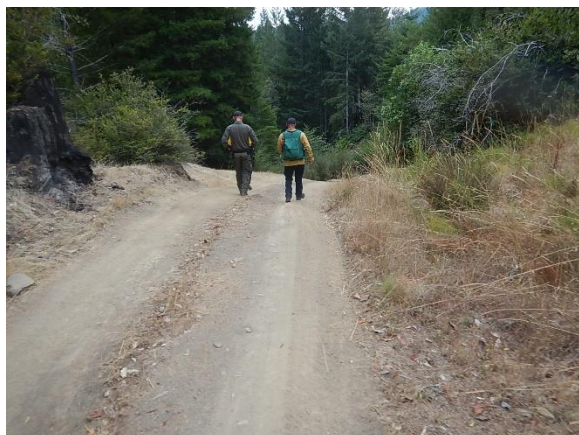
Figure 40. Road below CA1 that leads to point of delivery to Class III watercourse.

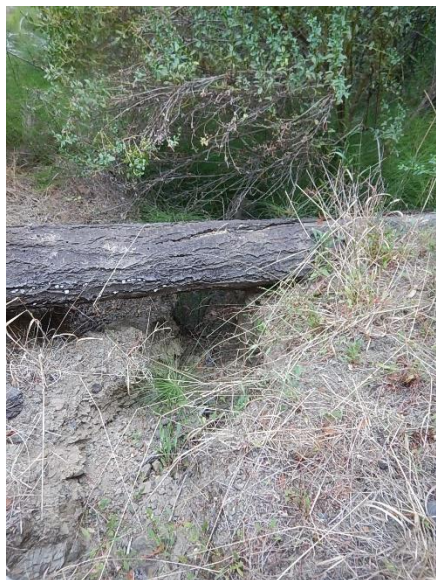
Figure 42. Scoured channel below the road where concentrated runoff is routed downslope via Class III watercourse.

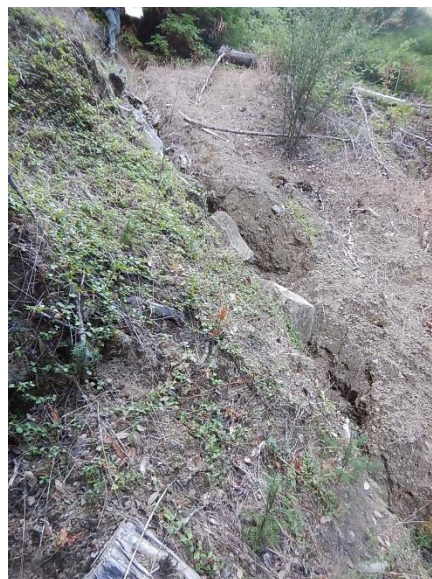
Figure 43. Scoured channel below the road where concentrated runoff is routed downslope via Class III watercourse.

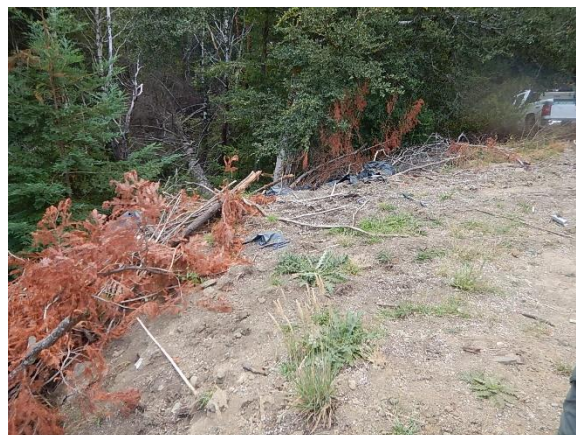
South of CA1, cultivation area CA2 (Map Point 11) is located on a cut and fill flat; cultivation waste and earthen fill has been discarded over the outboard edge of the flat. Runoff from this area and adjacent roads concentrates and has scoured a flow path to deliver concentrated stormwater and sediment to the head of a Class III watercourse at Map Point 13.

Figure 49. Fill slope of cut and fill flat at CA2 is covered in cultivation waste and slash.

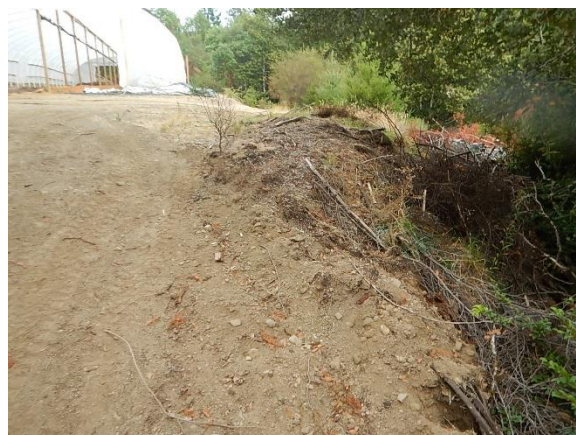
Figure 50. Runoff from CA2 flat concentrates down road.

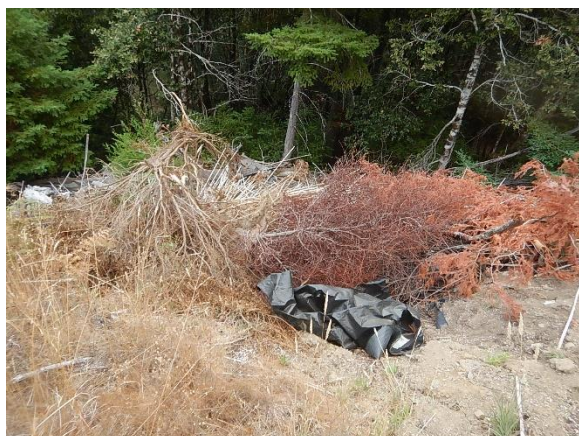
Figure 48. Fill slope of cut and fill flat at CA2 is covered in cultivation waste and slash.

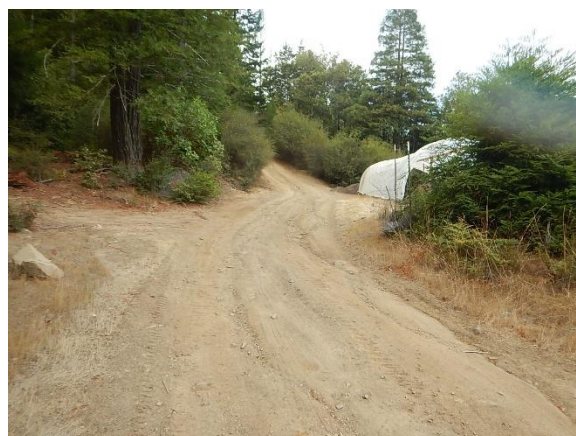
Figure 51. Runoff from CA2 flat concentrates down road.

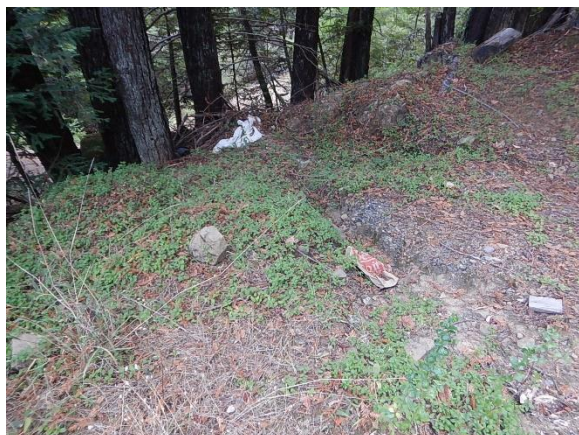
Figure 52. Scoured flow path toward Map Point 13.

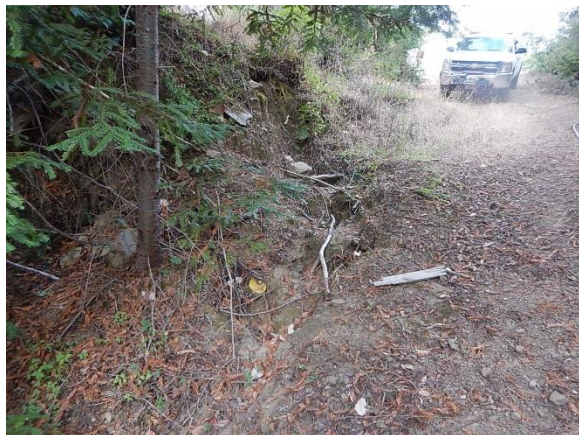
Figure 53. Discharge from CA2 and road runoff concentrates and transports to the head of a Class III at Map Point 13.

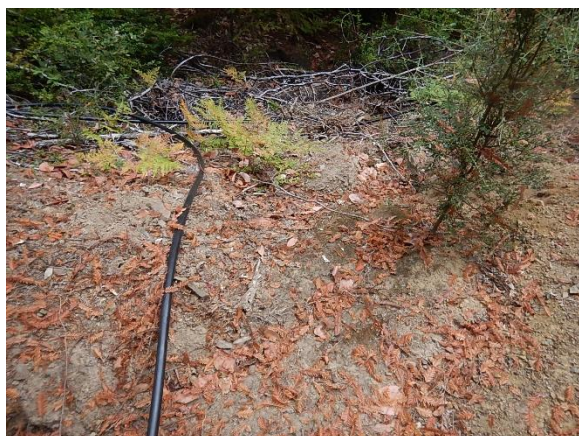
Figure 54. Discharge from CA2 and road runoff concentrates and transports to the head of a Class III at Map Point 13.

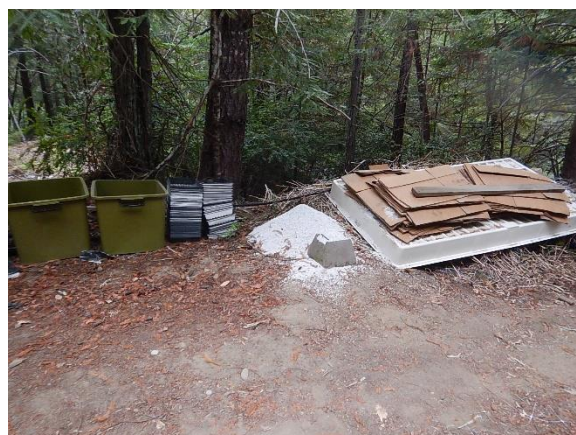
7. Fertilizers and soil amendments: As mentioned above, I observed an uncontained pile of perlite near Map Point 19. Apart from that, I did not identify any water quality concerns associated with the storage or use of fertilizers and soil amendments.

Figure 57. Uncontained perlite.

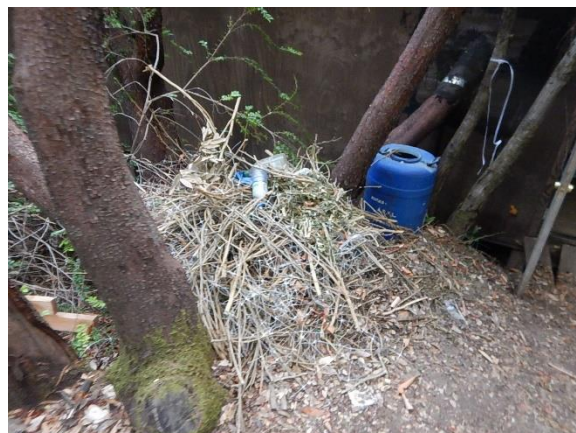
Figure 61. Cultivation waste outside indoor building.
